6 CORROSION CONTROL OF HARDENED INTERSITE  
CABLE SYSTEM (HICS) SPLICE CASE.

10 THOMAS F. LEWICKI

11 MAY 1979

9 FINAL REPORT

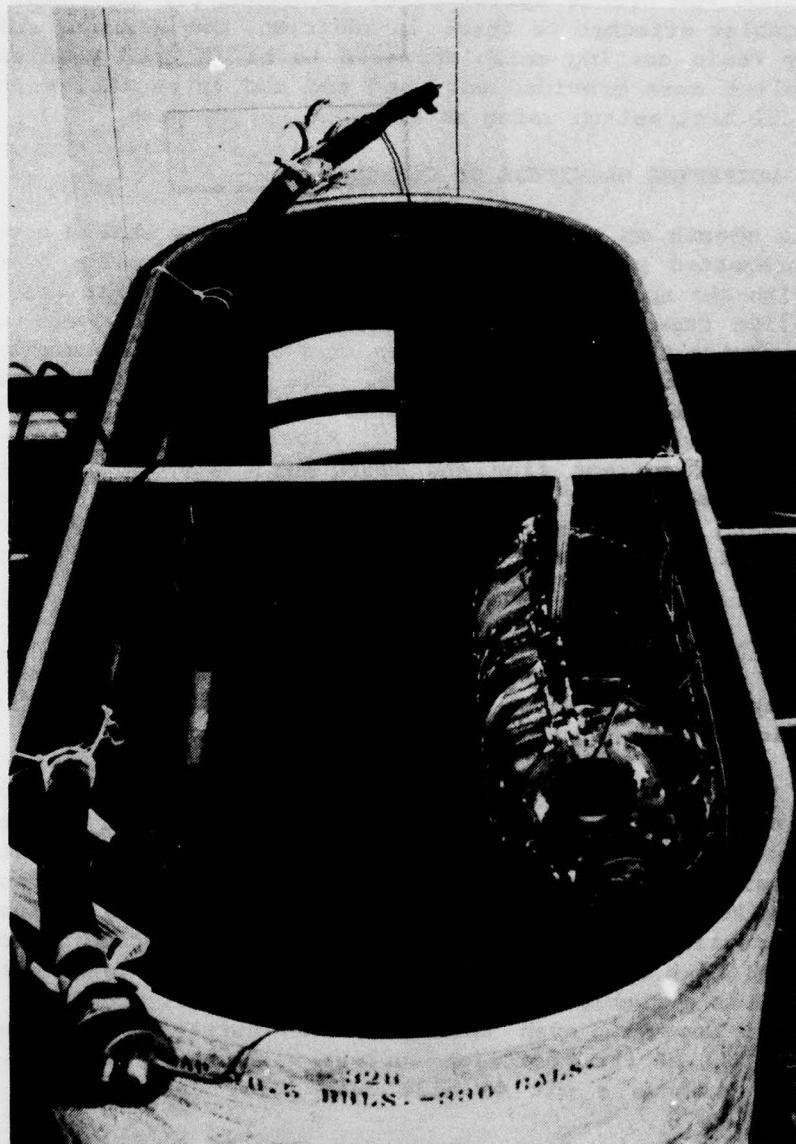
**Figure 2.** Aluminum Splice Case and Two Graphite Impregnated Cables Positioned Inside a Coated Steel Trough

The aluminum and bronze splice cases furnished for this test were new and had two cables attached to them. In addition, the aluminum splice case had an epoxy resin coating which appeared to be in good condition. The cast iron splice case provided was used and had three cables. Figure 2 shows a typical test set-up using an aluminum splice case.

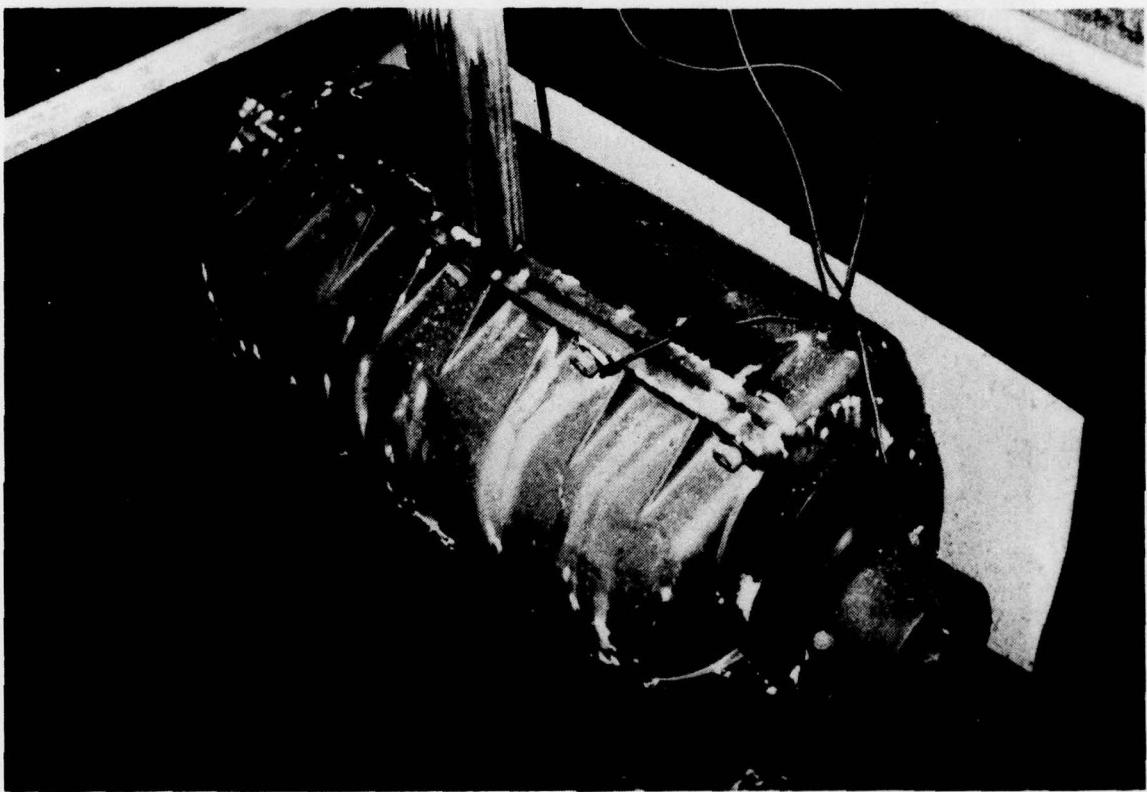
2. Aluminum Splice Case. A startling result of the lab test was the fact that the initial corrosion current for the coated splice case was so high, since corrosion can only occur at holidays in the coating. The initial corrosion current was 4.99 ma but it rapidly decreased to a steady .10 ma within 20 days. Corrosion damage was confined to holidays in the epoxy resin coating as evidenced by the white tubercule formations of aluminum oxide which are visible in Figure 4. The high resistance of this aluminum oxide is probably what caused the significant reduction in corrosion current. However, even this corrosion current caused substantial damage, since all of the corrosion current was concentrated at the holidays. Figure 5 shows a pit 40 mils deep after only 60 days exposure.

Figure 4. Corroded Aluminum Splice Case After 60 Days Exposure

**Figure 5. Close-up of Corrosion Damage to Aluminum Splice Case**

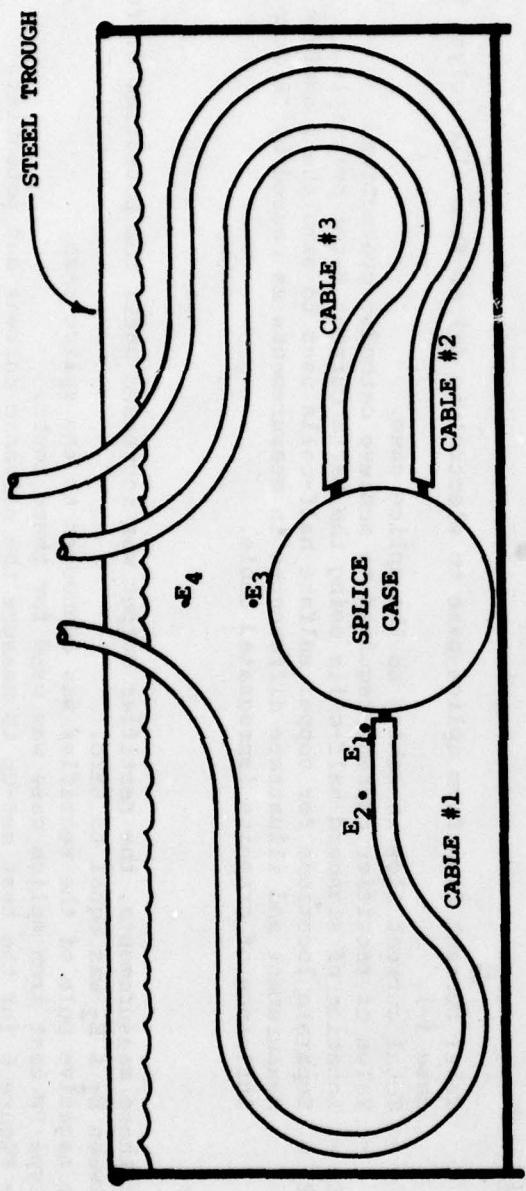
Figure 6. Set-up for Galvanic Current and Potential Measurement in the Lab

In the lab, cathodic protection was used to reduce the corrosion current to zero at the point of maximum corrosion. Table 5 shows the currents of the splice case, the cables, and the rectifier with the rectifier on and off. Also shown is the potential between  $E_1$  and  $E_2$ , and the structure-to-earth potentials of the splice case, close ( $\frac{1}{4}$  inch above the splice case) and at the surface of the electrolyte (5 inches above the case). Figure 6 shows the test set-up. Figure 7 shows the circuitry used to measure the rectifier current.

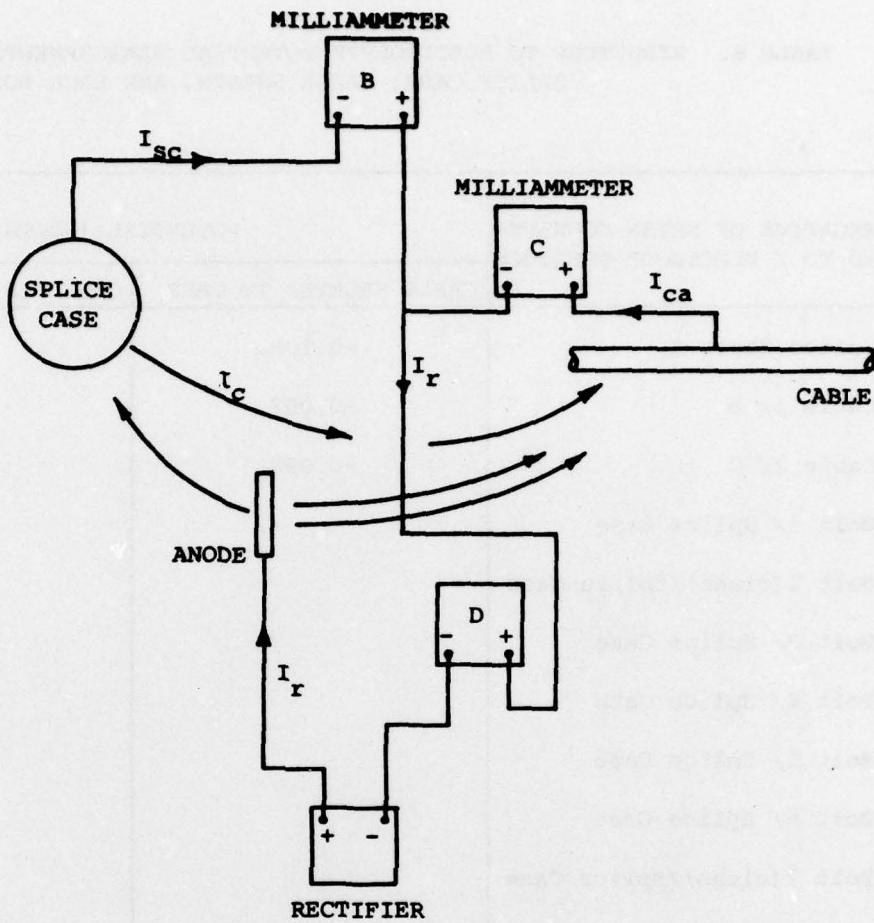
**Figure 7. Circuitry Used to Measure Rectifier Current**

Referring to Table 5 and Figure 7, without cathodic protection the galvanic corrosion current ( $I_{sc}$ ) is equal to the sum of currents in each cable ( $I_{ca}$ ). When cathodic protection is applied, the polarity of  $I_{sc}$  will reverse before the potential between the electrodes becomes zero. Therefore,  $I_{sc}$  is negative when corrosion of the splice case is stopped by cathodic protection, and  $I_{ca}$  is much greater with cathodic protection current flowing. When the rectifier is off, the structure-to-earth potential decreases as the electrode is moved farther away from the splice case. This is because the potential is influenced more by the graphite when the electrode is further away from the splice case. The structure-to-earth potential,  $E_4$ , is greater than  $E_3$  when the rectifier is on, because the potential is influenced more by the impressed current anode when the electrode is farther away from the splice case. Also, a potential drop caused by rectifier current flowing through the electrolyte between the electrode and the splice case will add to the potential  $E_4$ .

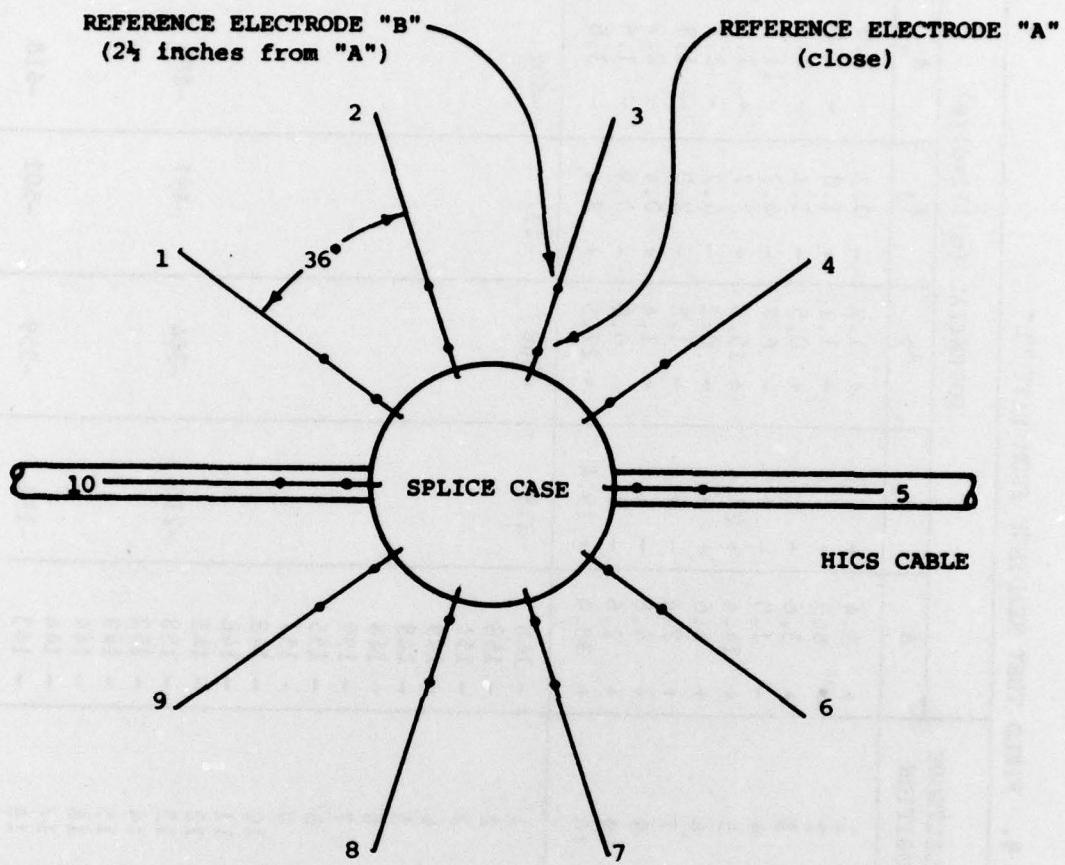
**Figure 14.** Set-up to Measure Earth Potential Drop (Two Electrode Method)

A cast iron splice case at site E and an aluminum splice case at site L were excavated and tested. It was determined that the aluminum splice case at site L is affected only by the rectifier at LF B-2. The magnitude of the corrosion currents leaving the splice cases was detected by placing two electrodes close to the splice case and moving them radially around the case as shown in Figure 14. The potentials measured are shown in Table 9 and Table 10.

The aluminum splice case was tied to one  $7\frac{1}{2}$  inch circumference graphite-impregnated cable at a depth of four feet. Maximum corrosion on the aluminum splice case occurred at position 10 (Table 9 and Figure 14). The corrosion current leaving the splice case and traveling to the cable sheath caused a potential drop in the earth of 38.4 millivolts. Structure-to-earth potentials were measured with the electrode positioned as shown in Figure 15. Structure-to-earth potential number 19 was the highest negative leading indicating the strongest anodic area. Structure-to-earth potential reading number 18 was taken at the top of the bank. All other readings at site "L" were taken within the ditch. For this reason, location number 18 was used to determine the surface potential at which the aluminum splice case was adequately protected.
